Conservation report

Lime kiln and farm buildings, Harper's Island, Glounthaune, County Cork

Prepared by
John Cronin & Associates
3A Westpoint Trade Centre
Ballincollig
County Cork

March 2024

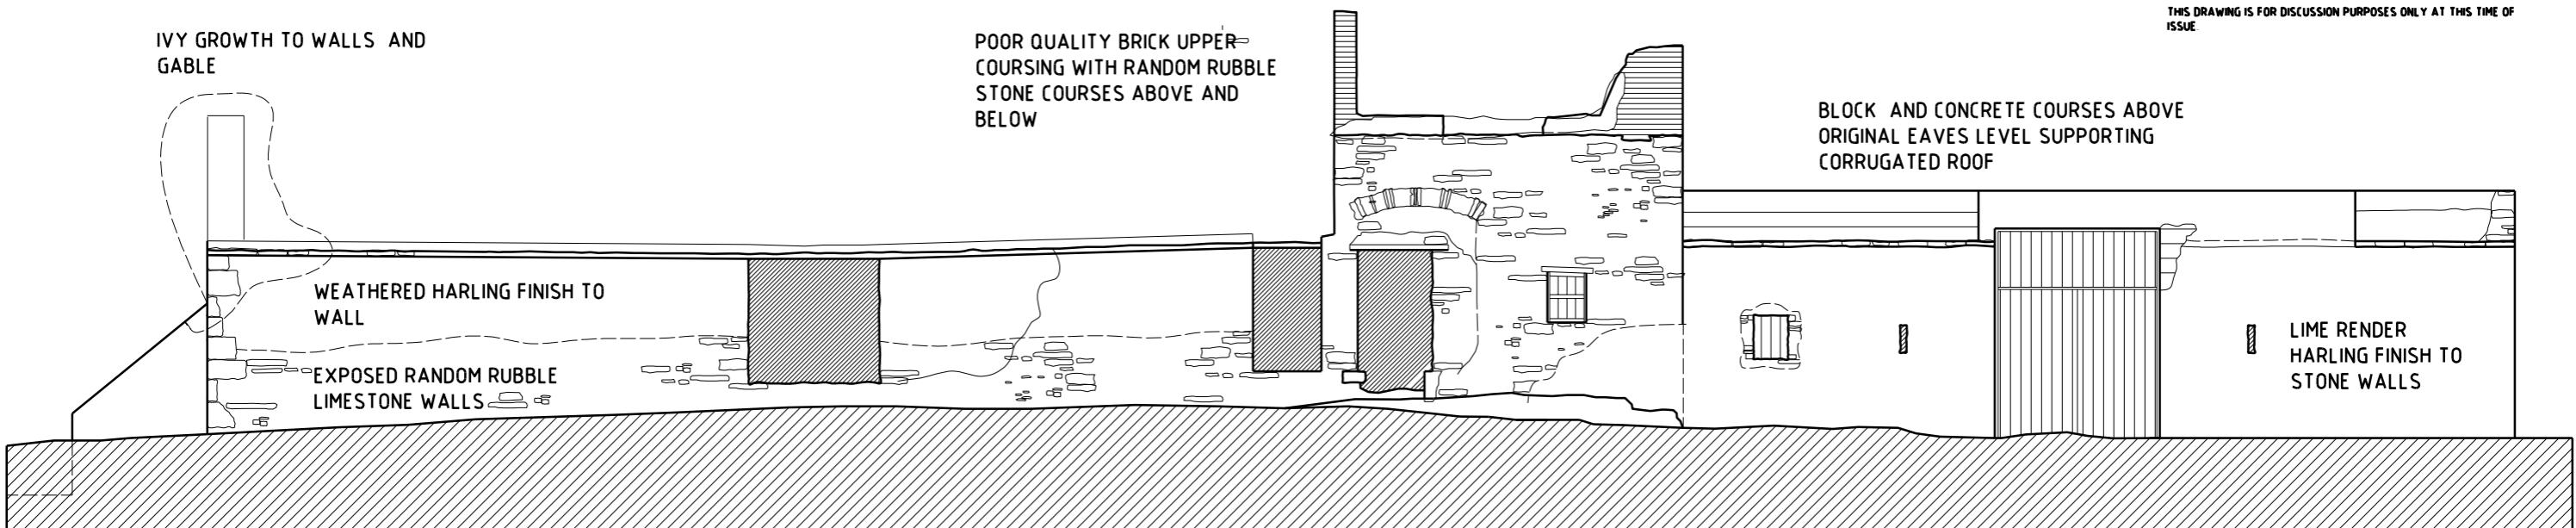
EAST ELEVATION

PREVIOUSLY WIDER ENTRY DOOR
REDUCED IN WIDTH AS SHOWN
RANDOM STONE ARCH OVER.

MODERN TIMBER SHEETED DOOR TO PART
FLOOR OF NORTHERN WING

MODERN ARTIFICIAL SLATE ROOF

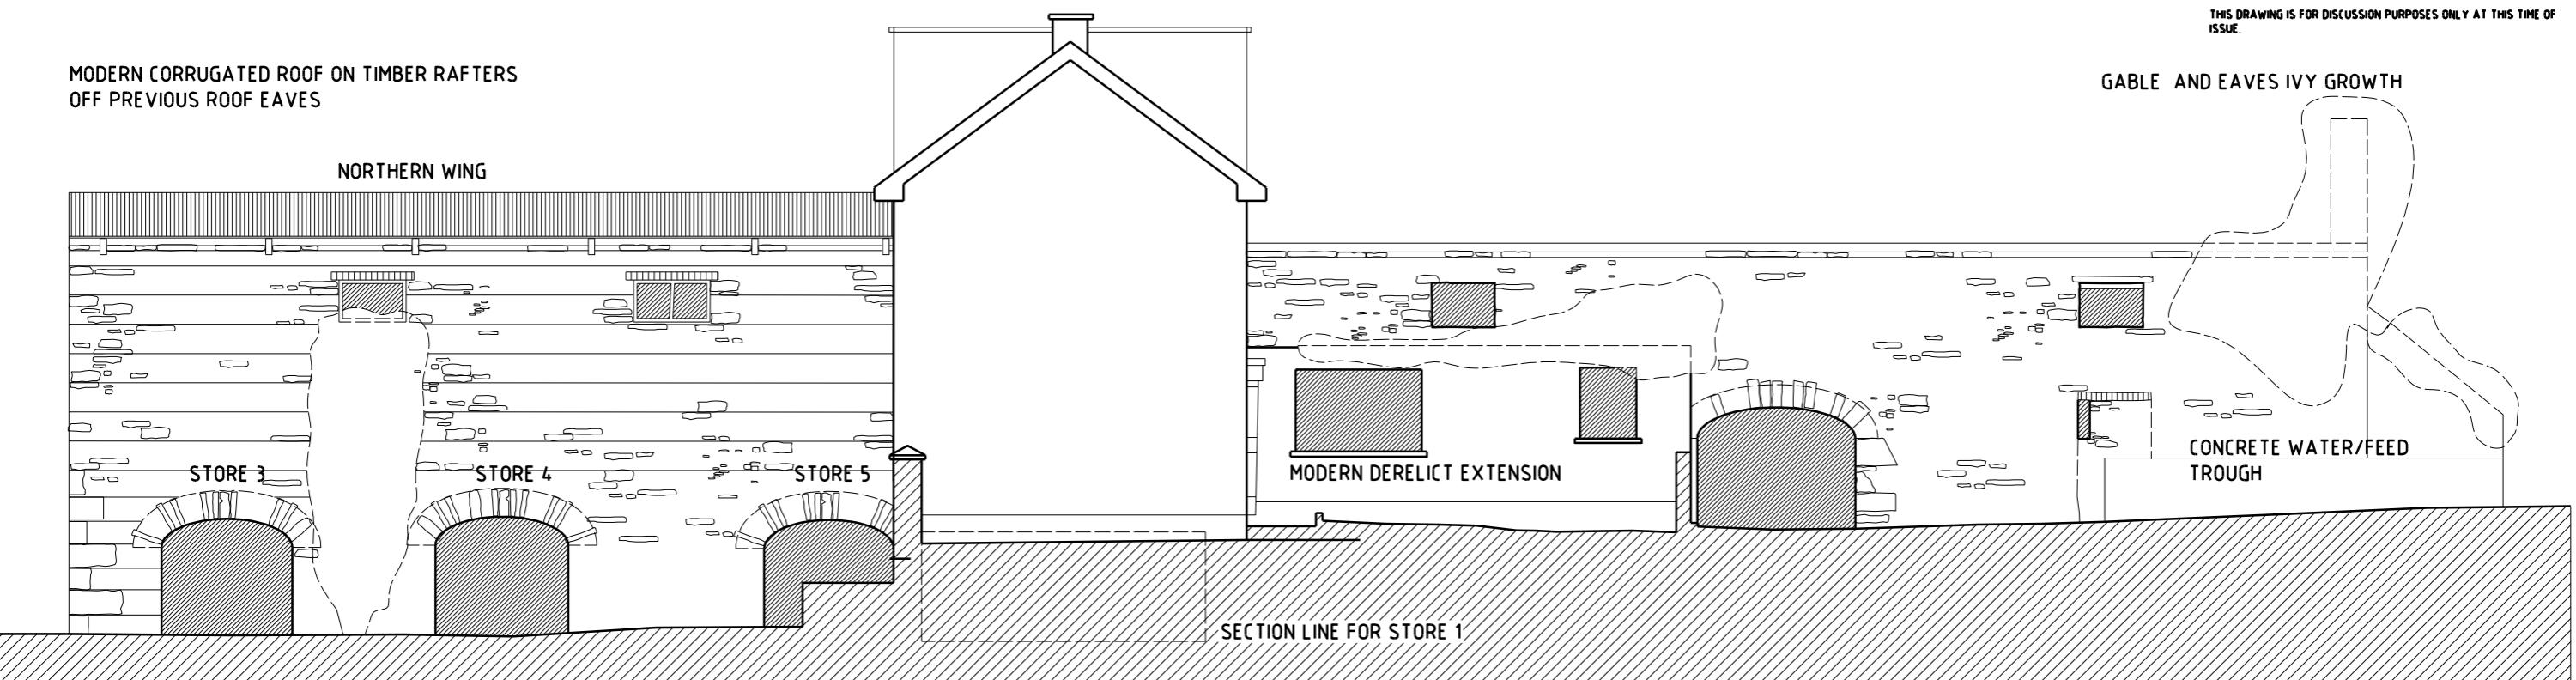
WEST ELEVATION

MODERN CORRUGATED ROOF ON TIMBER RAFTERS
OFF PREVIOUS ROOF EAVES

PART COURSED RANDOM RUBBLE LIMESTONE
AND SANDSTONE TO LOWER COURSES WITH
LARGE BOLSTER QUOINS TO PARTS TO GABLE.

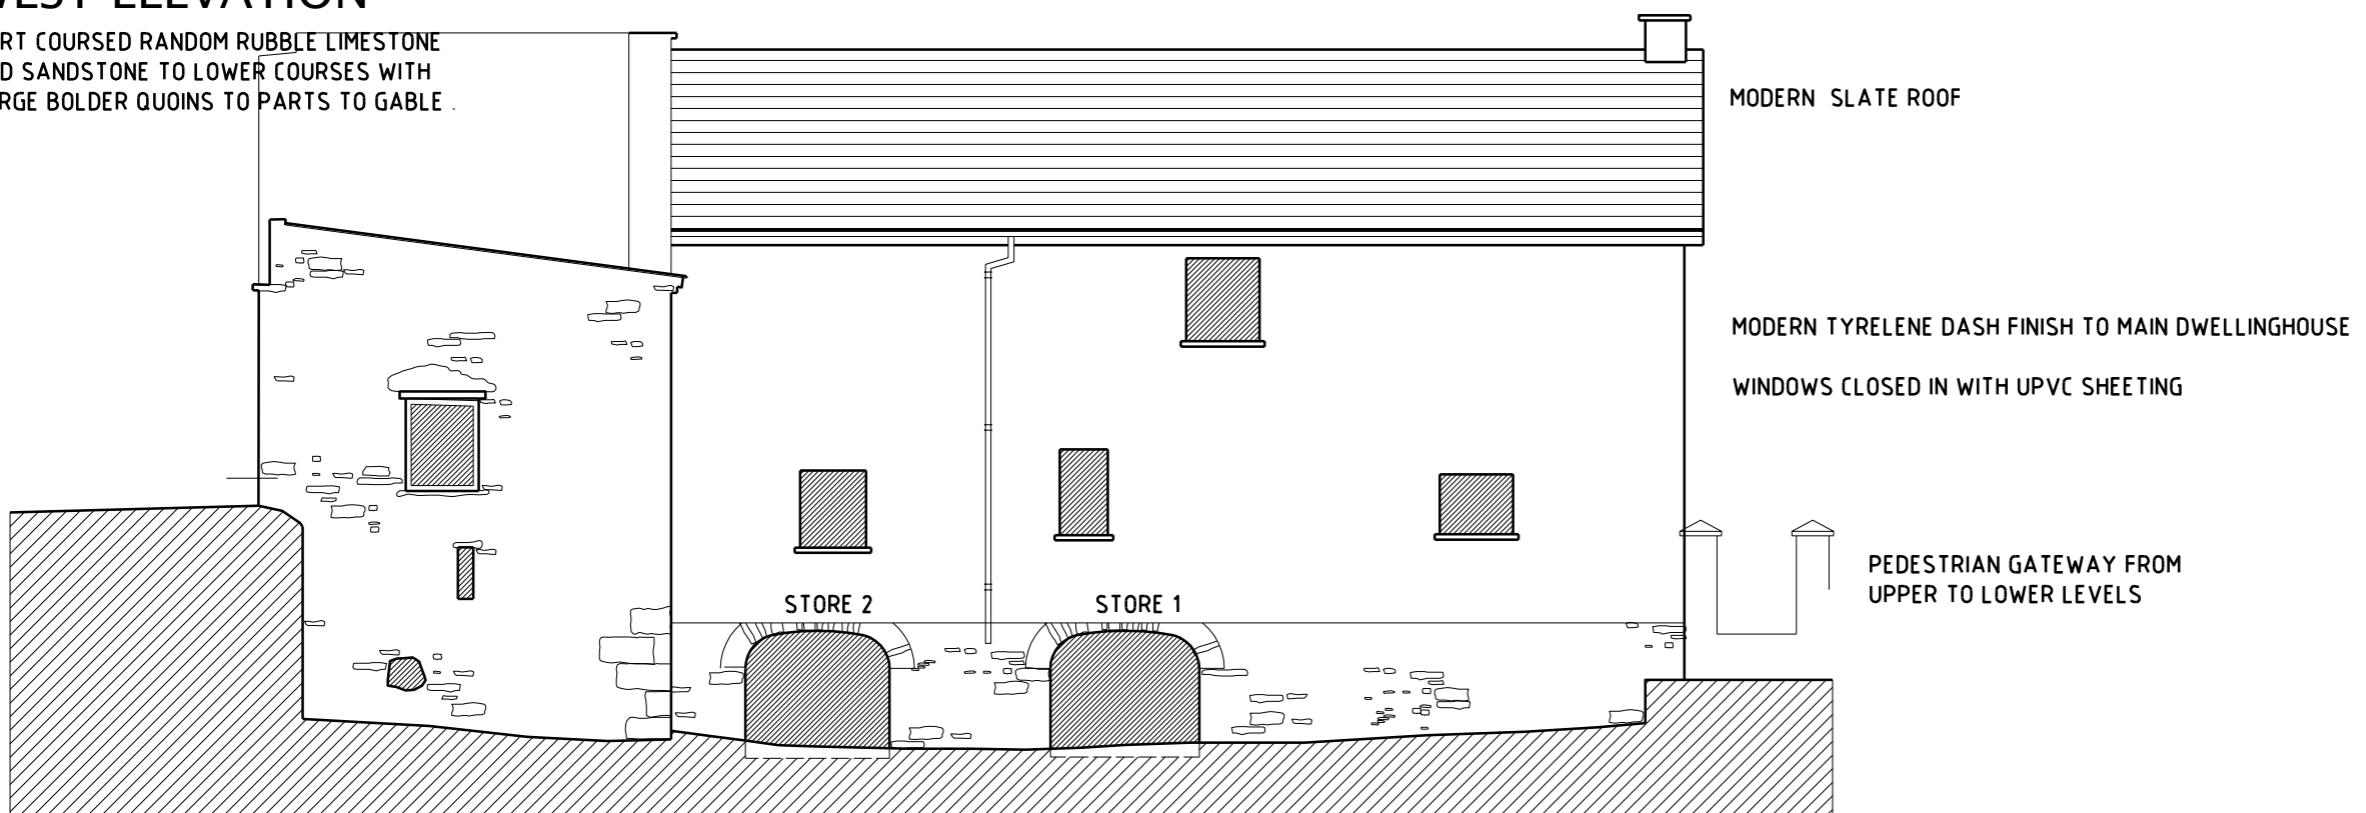
NORTH ELEVATION

PART COURSED RANDOM RUBBLE LIMESTONE
AND SANDSTONE WITH HEAVILY WEATHER
HARLING RENDER OVER TO GABLE.

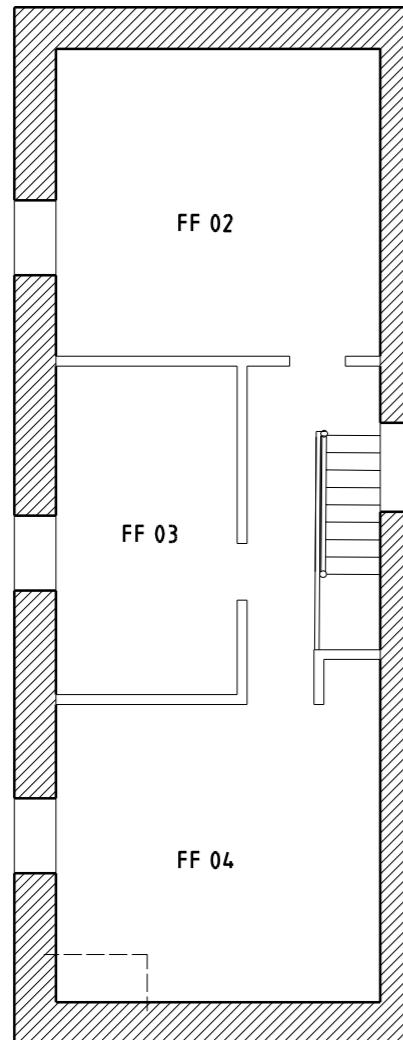
FIRST FLOOR PLAN

PARTS OF ROOMS INACCESSIBLE DUE
TO STABILITY OF FLOORS

MODERN STUD WALLS TO FIRST FLOORS

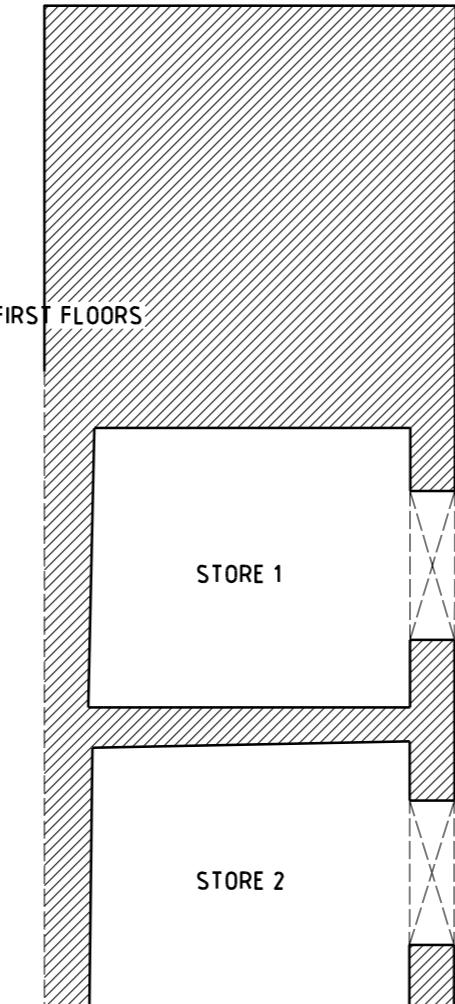
3 CENTRE CAMBER FLAT
ARCH TO STORES 1-2

OVER GROWN YARD AREA

REMAINING TIMBER BEAMS SUPPORTING
TIMBER FLOORS IN POOR CONDITION.
