Conservation report

Lime kiln and farm buildings, Harper's Island, Glounthaune, County Cork

Prepared by
John Cronin & Associates
3A Westpoint Trade Centre
Ballincollig
County Cork

March 2024

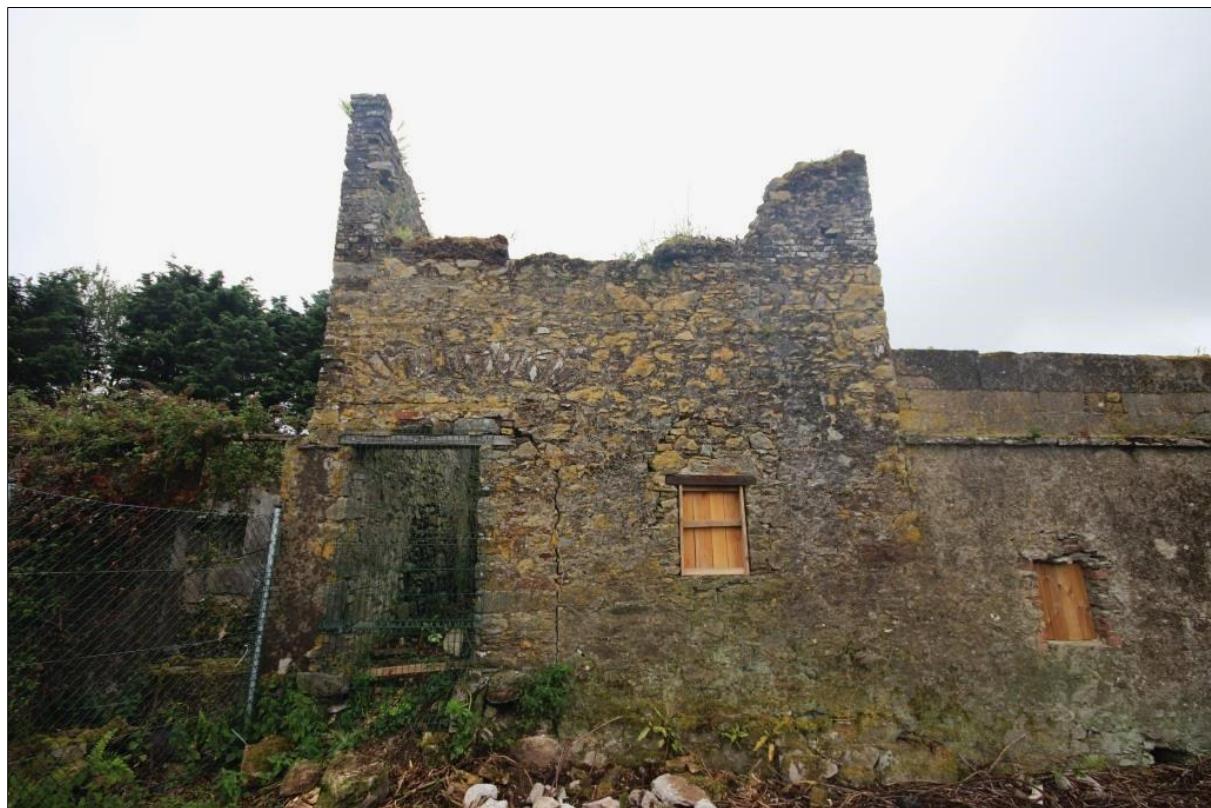
The eastern elevation has been much altered as the walls appear to have been raised in height with the insertion of a square-headed doorway and window opening (see **Plate 9**). The upper sections of the walls are of brickwork.

Plate 9: Eastern elevation

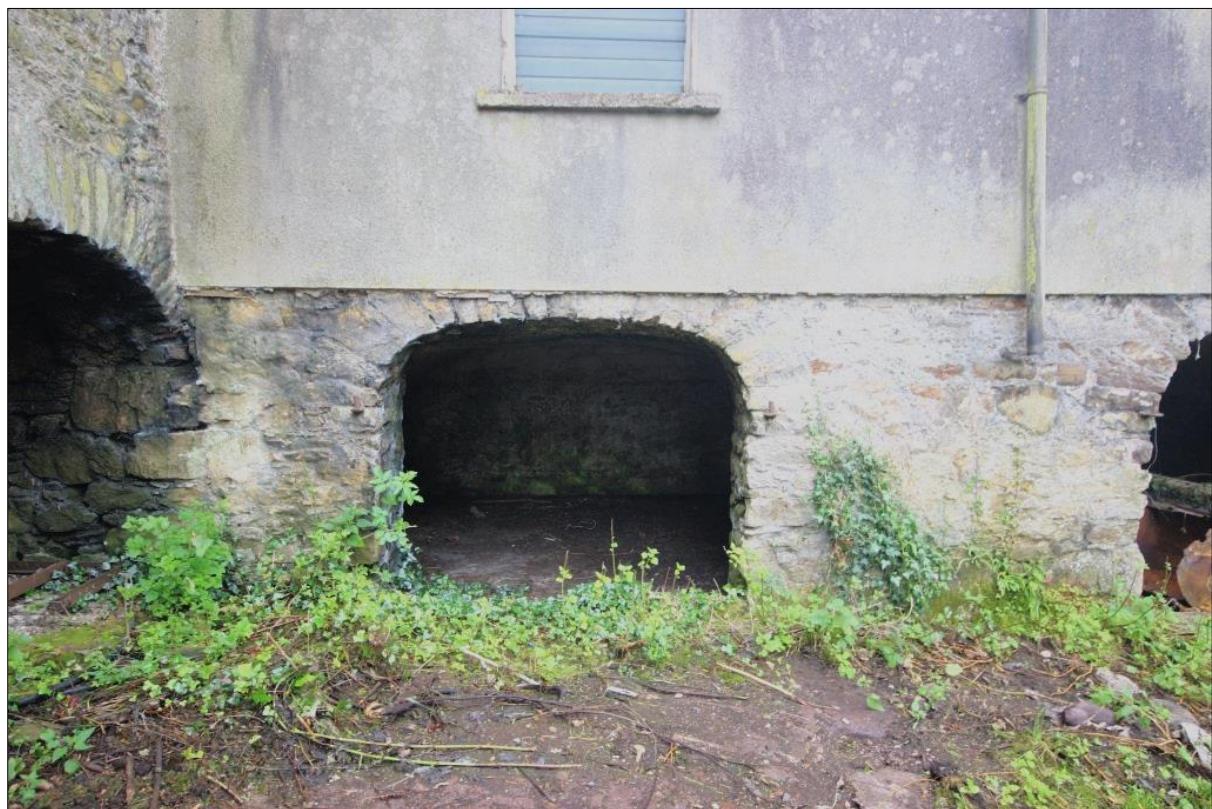
Plate 14: Arch to Store 1

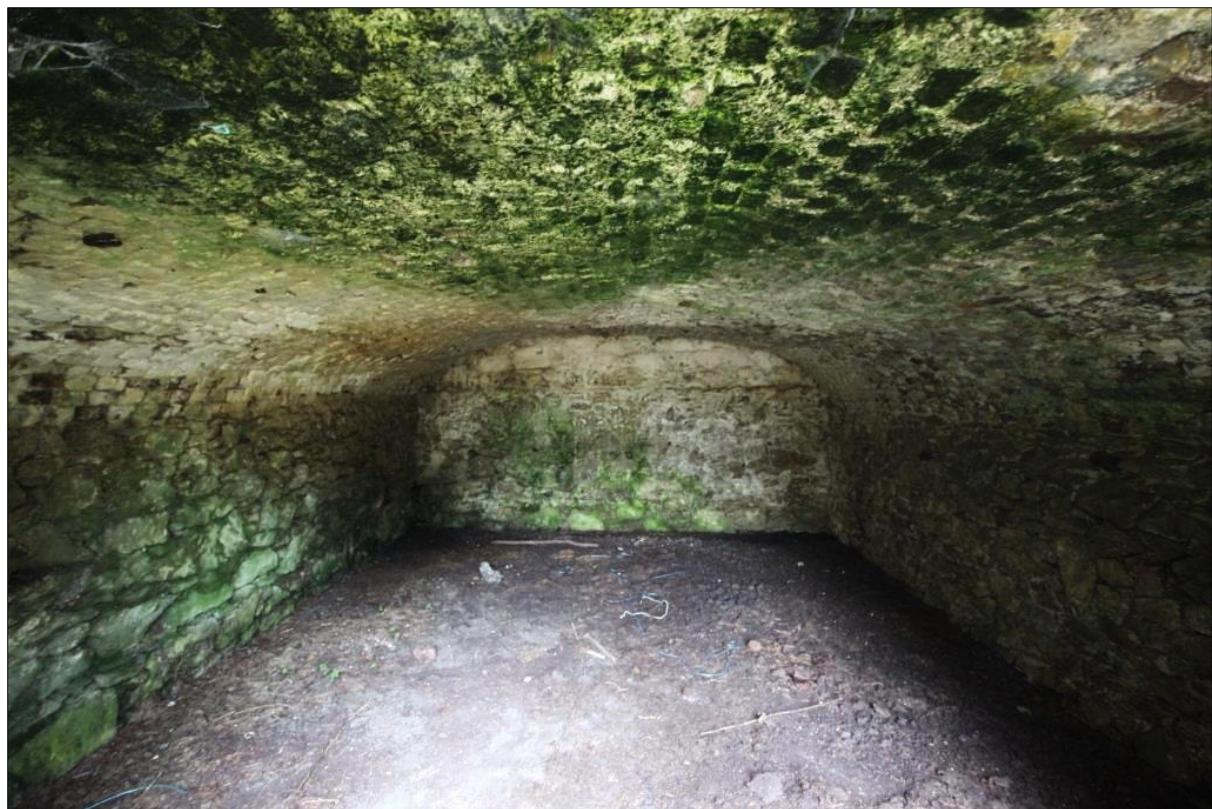
Plate 15: Interior of Store 1

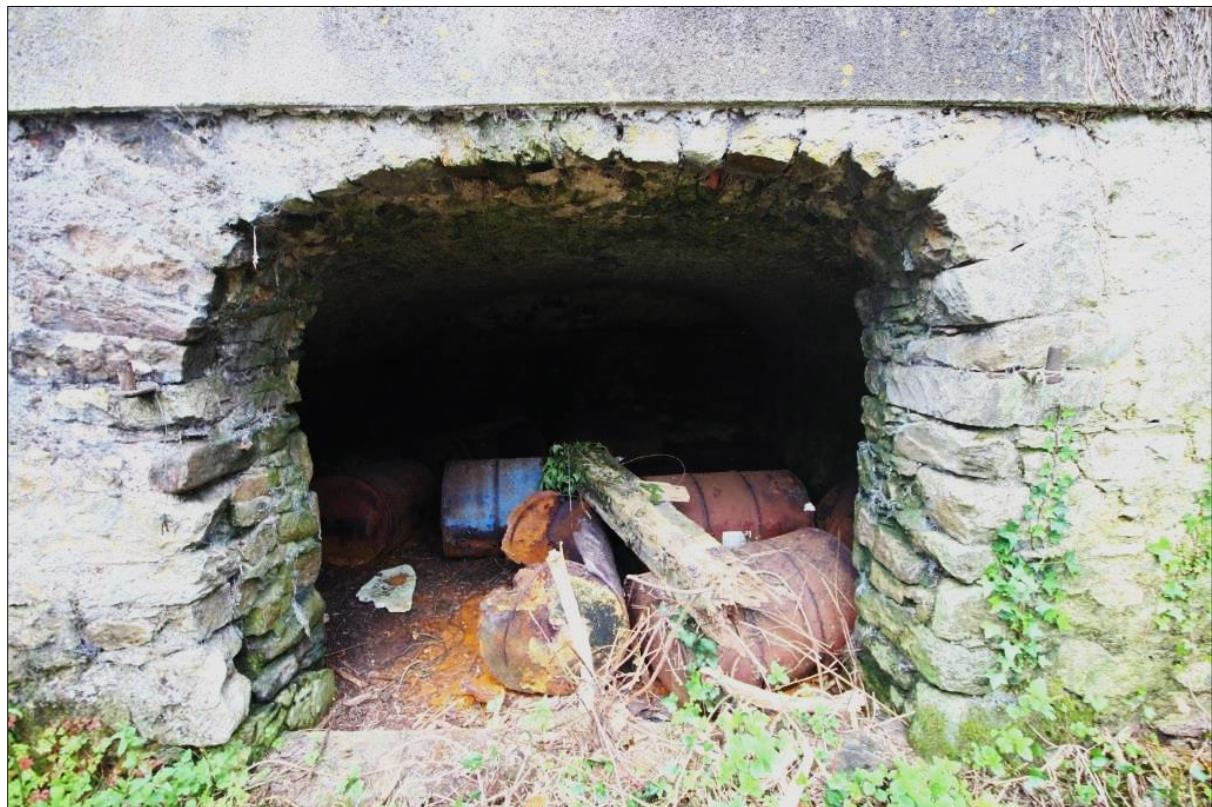
Plate 16: Arch to Store 2

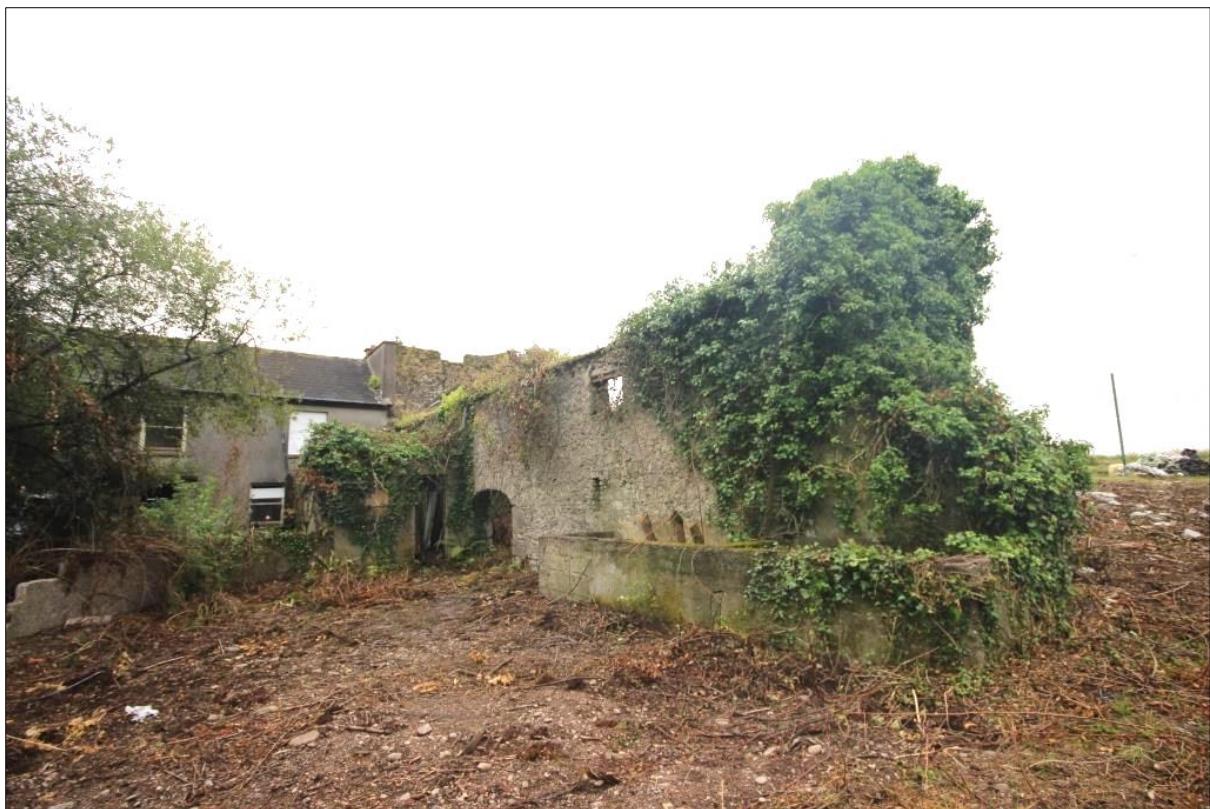
Plate 29: Western elevation of southern wing

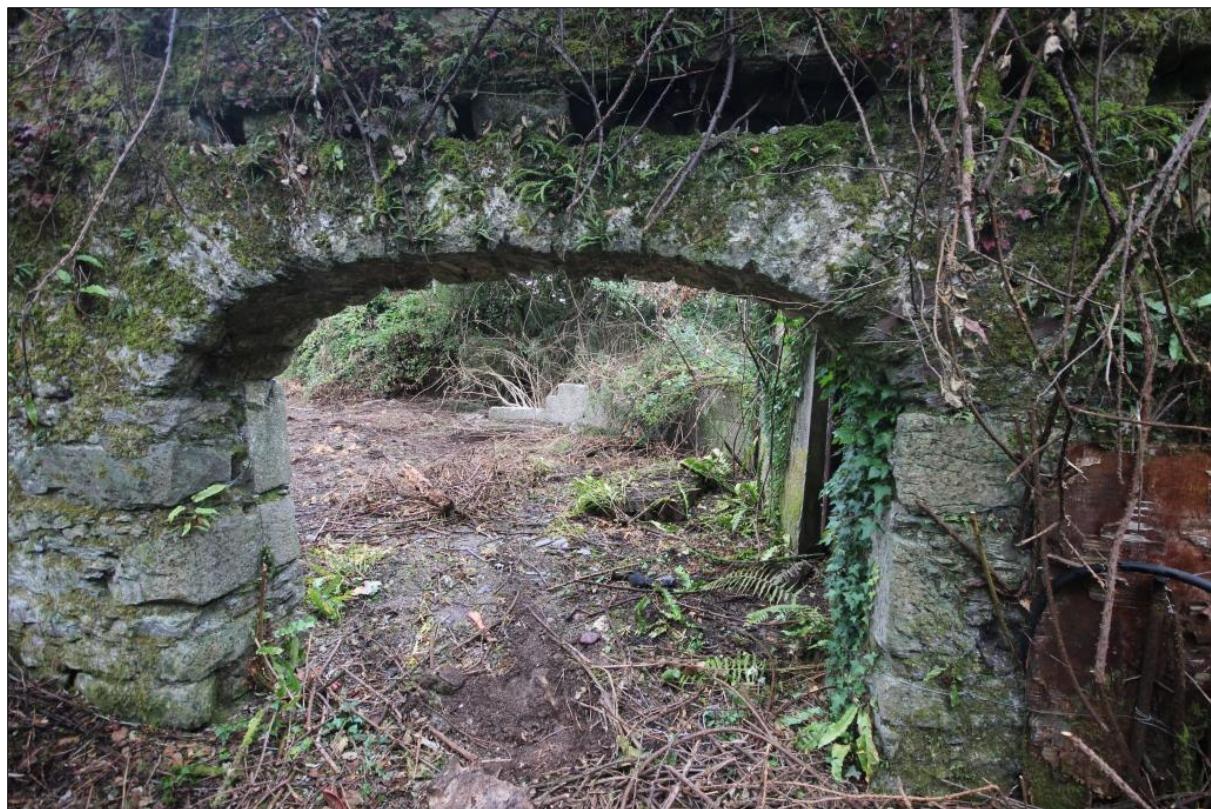
Plate 31: Arch detail in western elevation

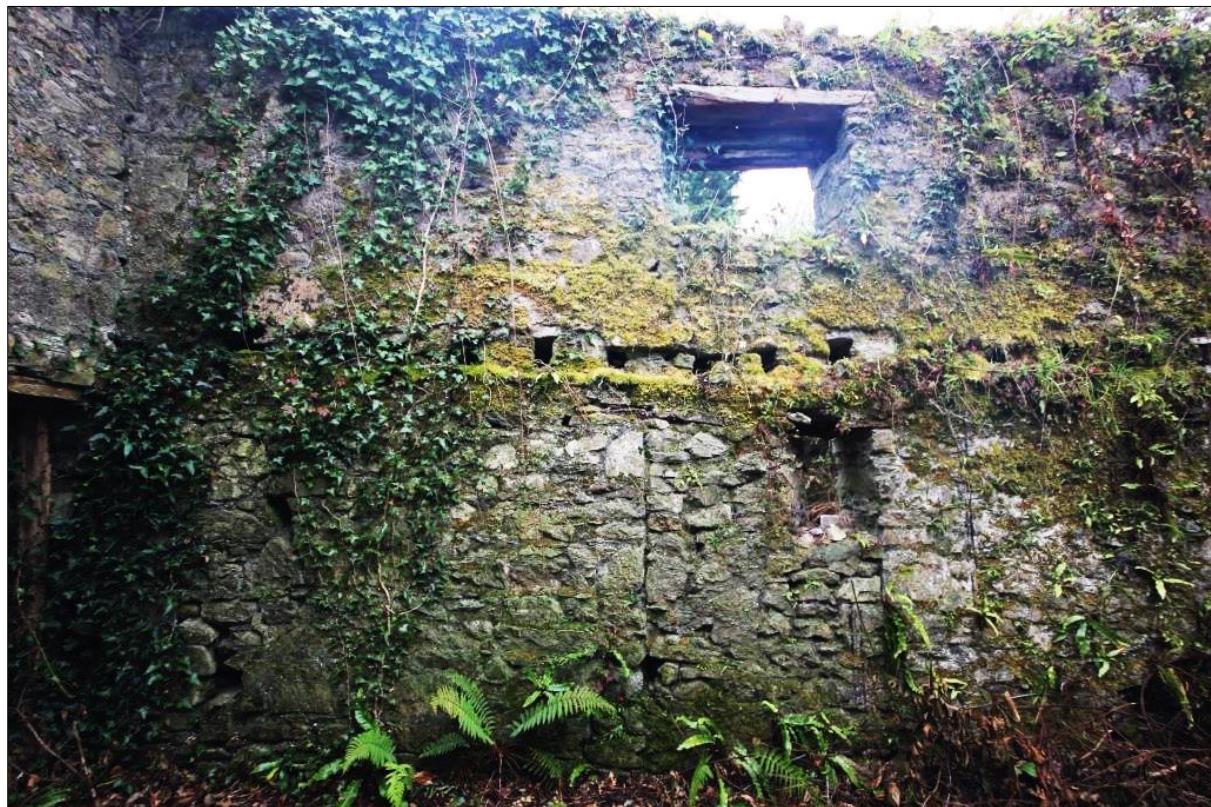
Plate 32: Putlog holes for floor joists and blocked up doorway

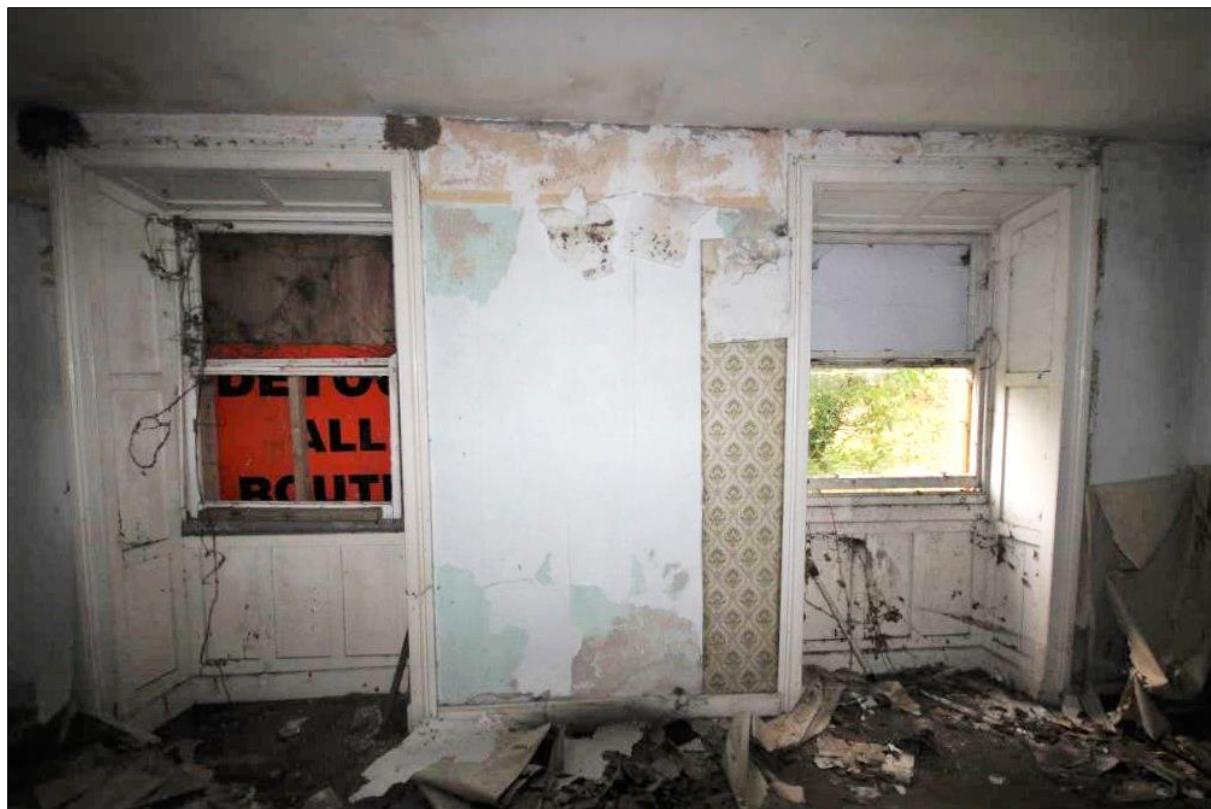
Plate 41: Ground floor windows in room GF02

The existing timber windows are in poor condition and in need of replacement. Existing timber sash **windows** should be replaced with appropriate hardwood windows that replicate the moulded detail and proportions of the existing twentieth-century windows.
